Thru Tubing Solutions' Abrasive Cutting System Performs Cut on Damaged 5.50" OD Casing, Creating a Cost Effective Solution to a Normally Very Costly Dilemma.

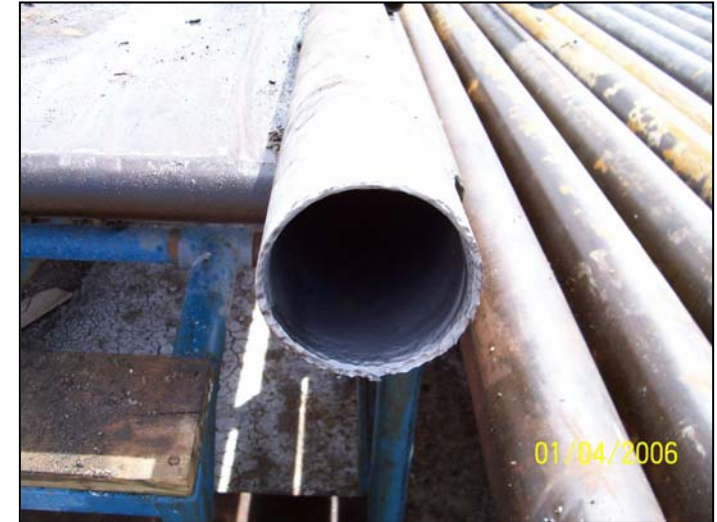
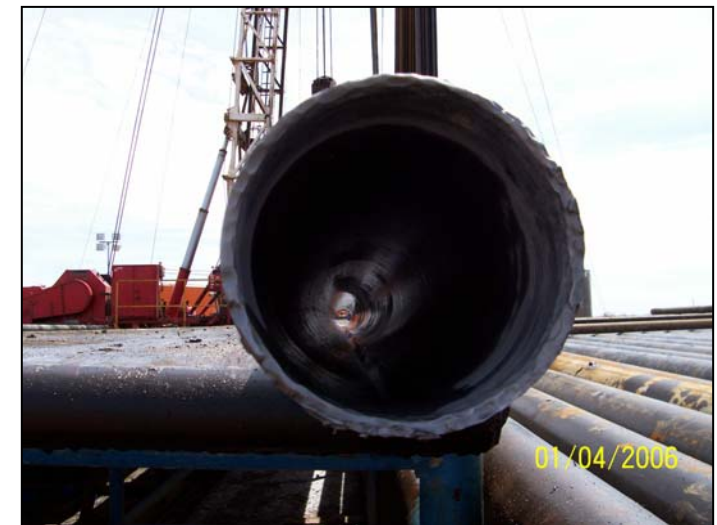
To cut 5.50" OD, 17# casing that had become shattered during a frac stimulation.

In 40 minutes pumping at 1 BPM the casing had been completely cut, allowing rig to pull casing out of the hole and latch back onto lower section of casing with new casing.

Damaged casing was cleanly removed. This expedited the re-completion of the well, avoiding costly and lengthy fishing of the damaged casing.
