# Abrasive Perforating

Abrasive Perforating Test thru Multiple Strings

Case Study No. 3202

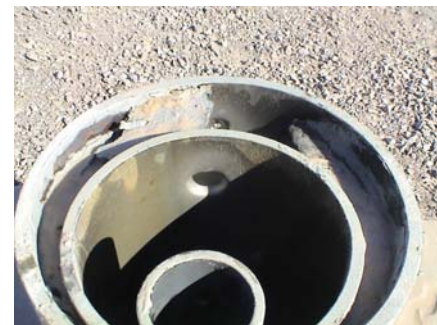
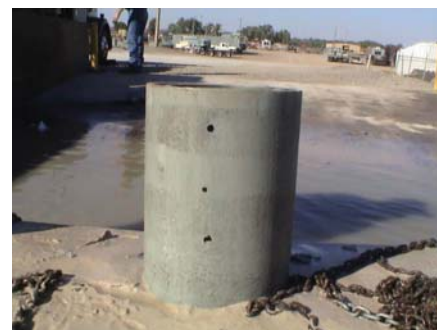
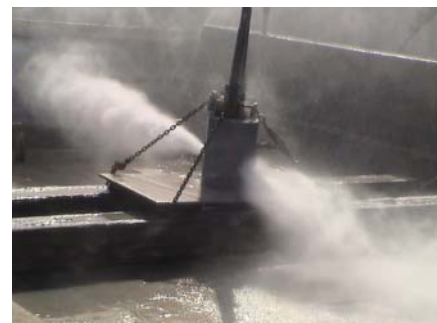
## TEST FIXTURE

The test fixture was built by installing 2 7/8" tubing inside of 7 5/8" casing inside of 10 3/4" casing, eccentrically welded to simulate a best and worst case scenario. The Abrasive Perforating BHA was chained with a tool clamp to the top of the fixture with the jets aligned to punch holes along a short and long axis. Perforating began working from bottom up by pumping slurry consisting solely of sand and water. The pump rate varied while prop concentration and prop type was constant with a maximum pump time of 20 minutes.

The results of the test concluded that it is possible to achieve reasonable sized perforations through multiple casing strings. A total of seven individual tests were completed with five independent variables. In one case, one of the perforations was cut in less than 30 seconds.
