**Thru Tubing Solutions' Abrasive Cutting System is deployed on 2-3/8" CS Hydril Pipe to cut 18.00" Casing.**

**Location:** Orlando, FL  
**Cut Depth:** 360'  
**Tools Ran:** 2.88" OD Motor Head Assembly  
3.13" OD Cutting Head  
**Fluid:** Water with 1 p.p.g. 100 Mesh Sand  
**Conveyance:** 2.375" CS Hydril Pipe

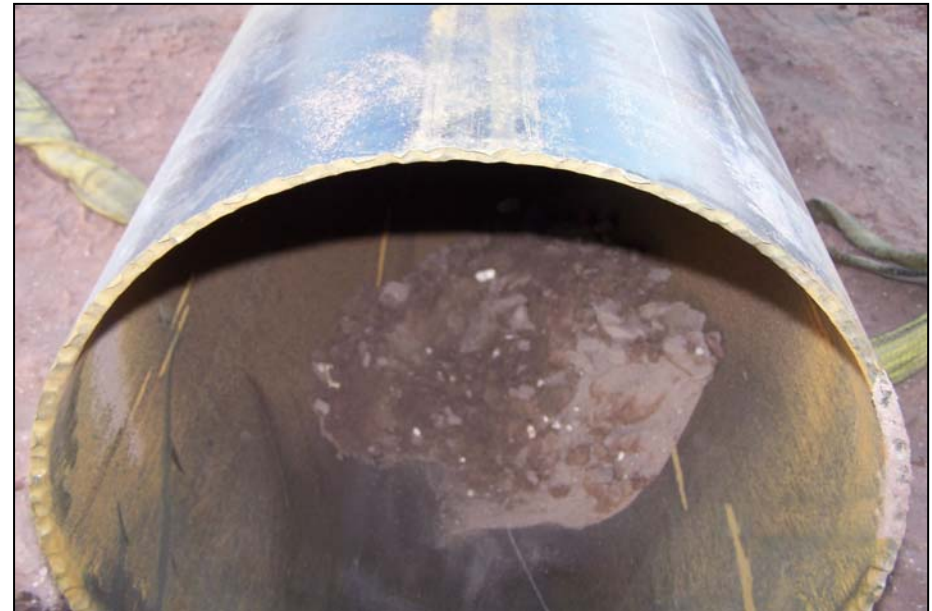
**Background:** Using 4.50" drill pipe, the operator deployed 18.00" casing, as a liner, with a right hand release joint. After the casing was run and cemented the release joint failed and the drill pipe could not be retrieved.

Casing was successfully severed in less than one hour pumping 2.50 b.p.m.

The operator contacted numerous service companies who specialize in cutting, however, no one believed that cutting the 18.00" casing was possible. Thru Tubing Solutions proposed running our Abrasive Cutting BHA on 2.375" CS Hydril tubing and rotating the Abrasive Cutting Head with a power swivel. The operation was flawless and the customer was able to resume drilling in the well.
